Harrison Towers East

VISUAL BUILDING ENCLOSURE CONDITION ASSESSMENT

**Harrison East
Condominium Owners
Association
c/o Seth Schade
BPM Management**

21-110

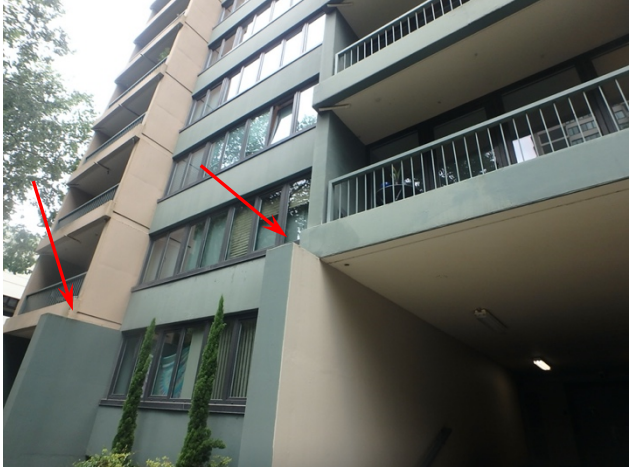
The exposed ledges are experiencing spalling of the paint and coatings.

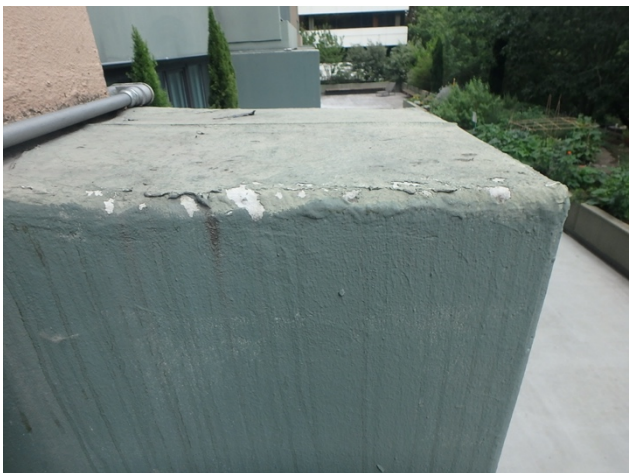
Close-up of the spalling and failed coating.

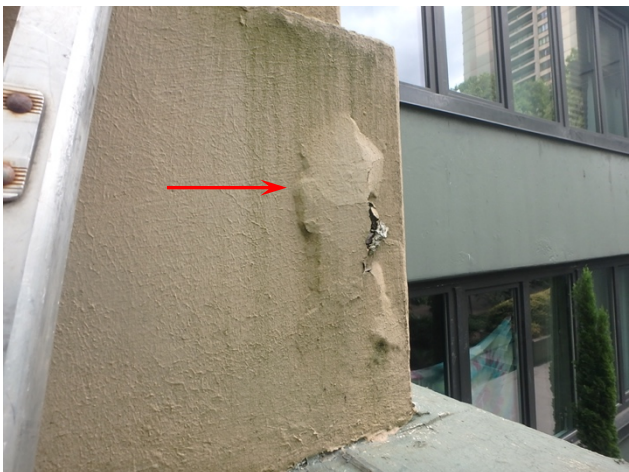
Water sitting on the horizontal ledge and water dripping from the balconies above.

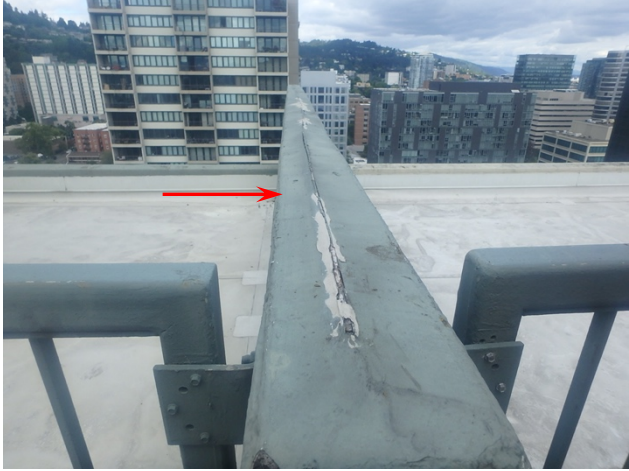
Exposed walls at the upper roof are also experiencing decay.

- The upper TPO roof should be budgeted for replacement and the tops of the exposed concrete walls covered with a metal cap or a fluid applied waterproofing.

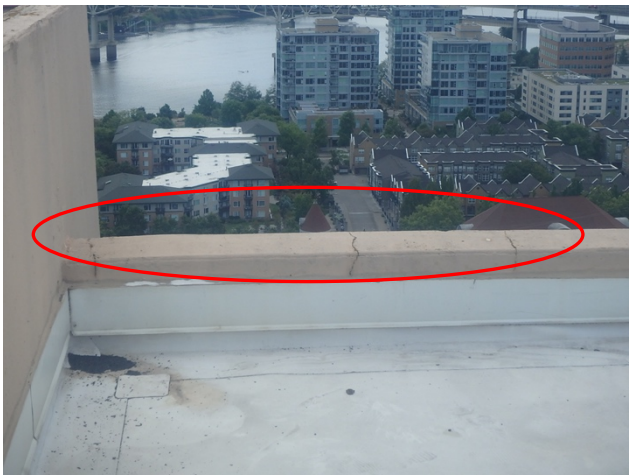
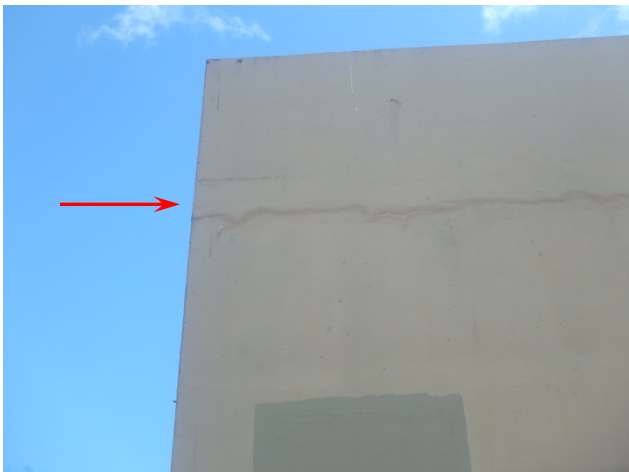
A large previous crack was noted in the penthouse mechanical tower but appears to be stable.

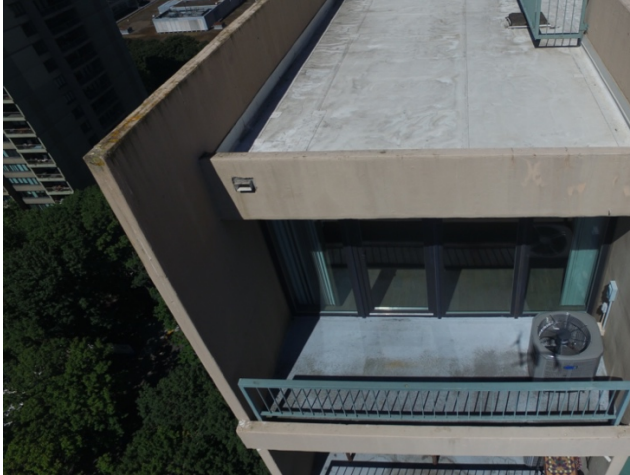
Dirt and debris on the concrete are typical and more concentrated at the upper levels.

- Cleaning and painting of the building is needed in the near future and should be budgeted for.
- **Follow-Up Meeting** – Meet with Forensic at your earliest convenience to further discuss our investigation findings and recommended next steps, and to begin to develop a plan for further action. The action plan will outline the following:

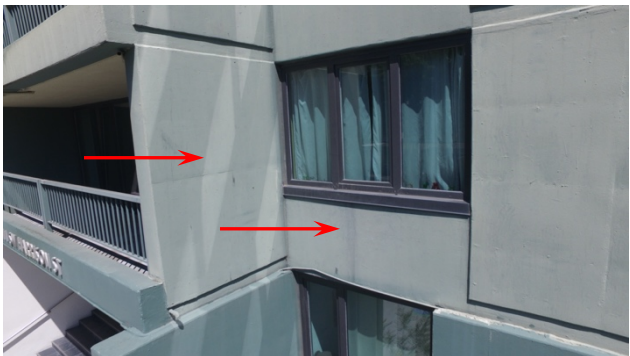
The exterior paint is generally faded and marred from window washing practices.

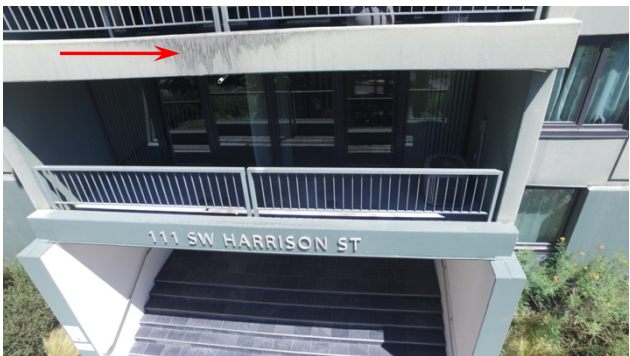
Staining and dirt typical at the balcony ledges.

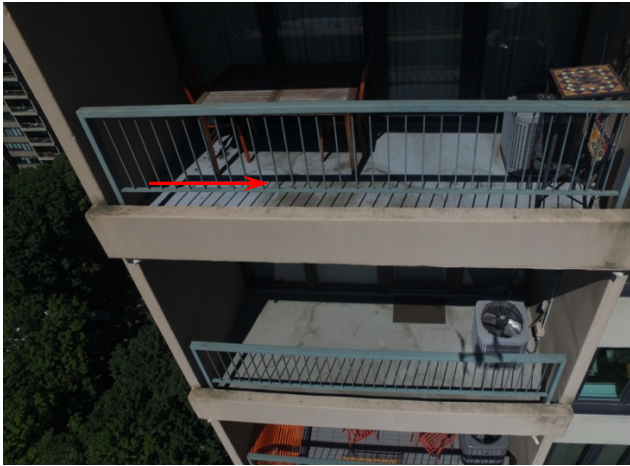
Private balconies are topped with a fluid applied waterproofing that typically require recoating every 7-10 years. The current coating is believed to be from 2006-2008 with some isolated units receiving repairs.

- The balconies should be planned for recoating in the near future. The unit on the north 4th level should be repaired immediately. During the recoating of the balconies the railings should be cleaned and painted with any areas of corrosion cleaned to bare metal and repainted. Spalled concrete should be removed and patched and the drain extensions resealed. A vertical downspout should be considered to manage the dripping water and prevent additional problems.

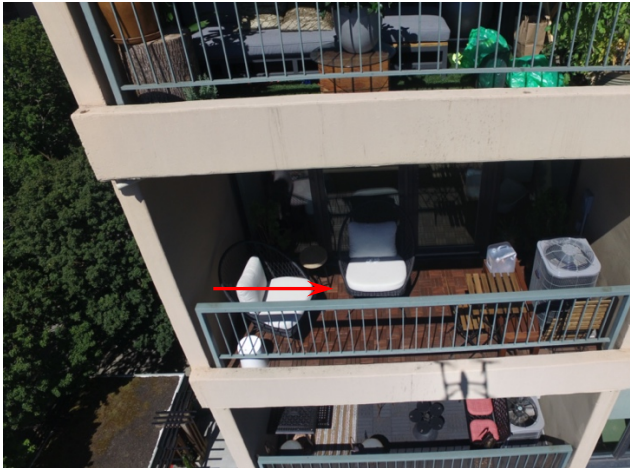
A majority of the balconies are covered by a floating floor or carpet and the coating is not visible.

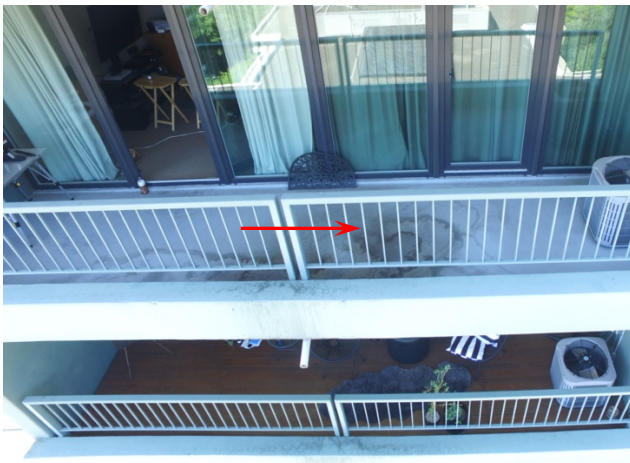
Balconies typically have signs of ponding or poor drainage.

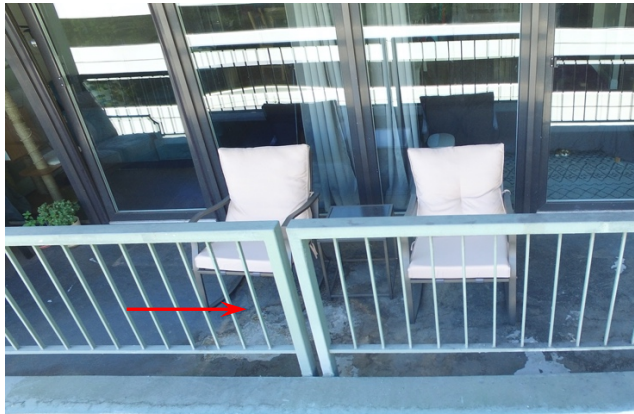
- The private balconies are in fair condition but have exceeded the expected service life before needing a recoating. A balcony on the North elevation 4th floor was observed to be in poor condition with extensive deterioration and signs of sealant work at the windows and doors.

North elevation 4th-floor unit has extensive spalling of the coating.

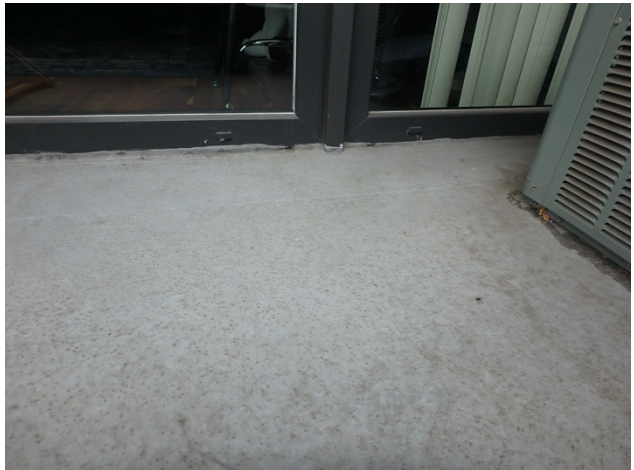
The waterproofing is beginning to delaminate in areas along the windows and doors of the units reviewed.

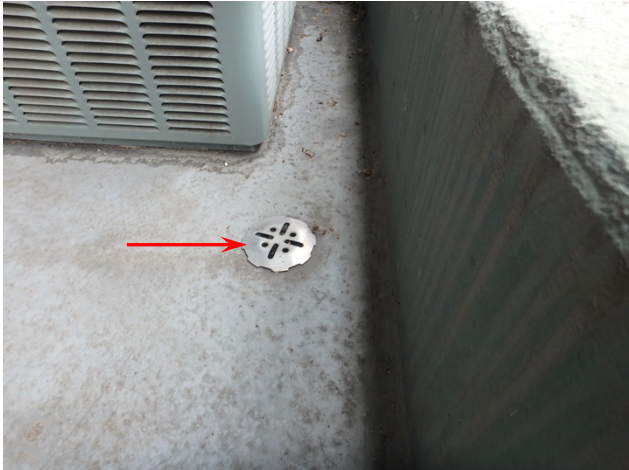
Most balconies have two drains at the outer face.

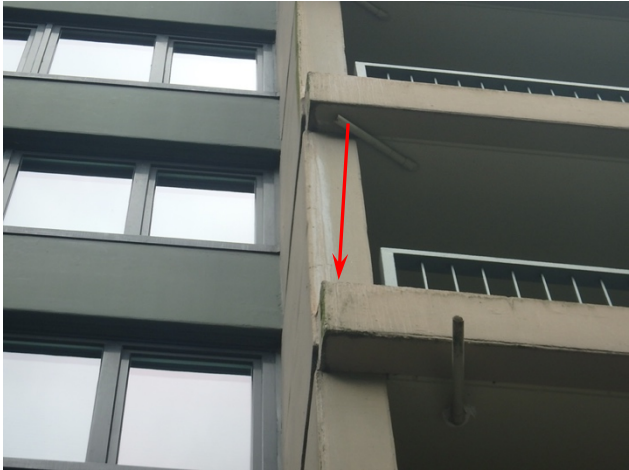
Pipe extensions have been placed to direct water away from the balcony below but still discharge water onto the exposed ledge causing the water staining and some localized spalling of the concrete.

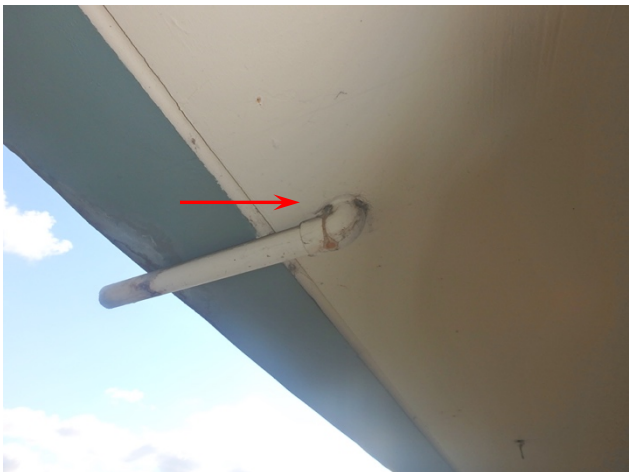
Many of the extension are showing signs of leakage that may be at the coating to leader in the concrete or at the pipe extension into the concrete.

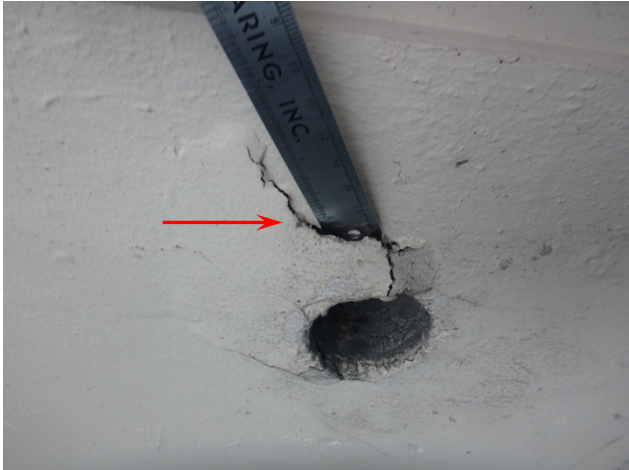
Several balconies have spalling at the underside leader termination due to water exposure.

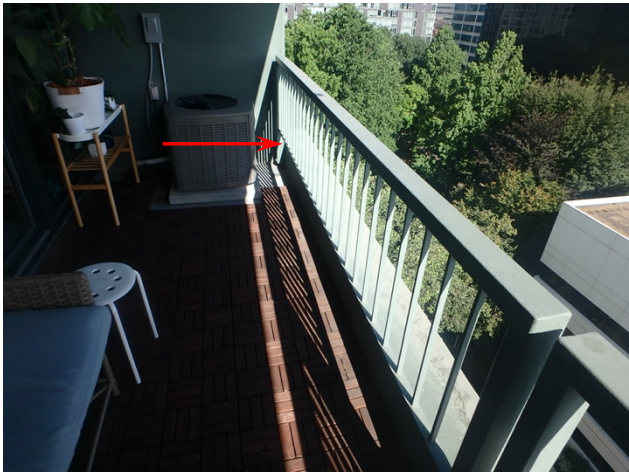
Guardrails are showing signs of deteriorating paint and corrosion at weld joints.

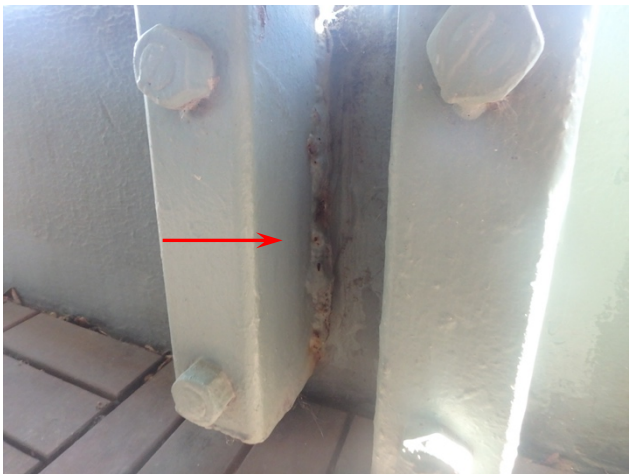
Minor corrosion at the weld between posts.

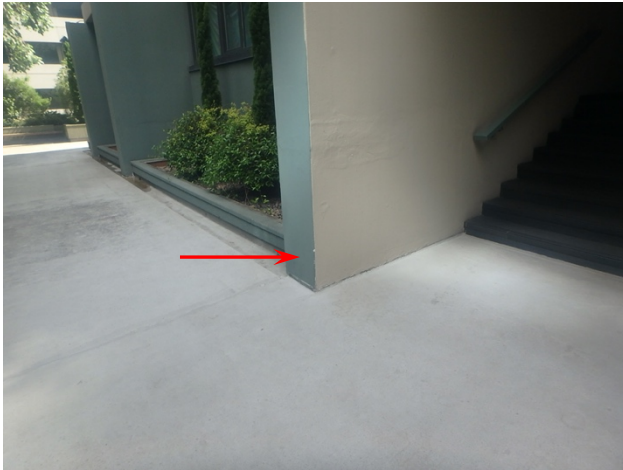
The waterproofing and sealants are systemically failing causing leaks below.

- The podium level plaza needs recoating and replacement of the sealant joints to avoid further damage to the concrete and any vehicles below. Areas of spalled concrete should be removed and

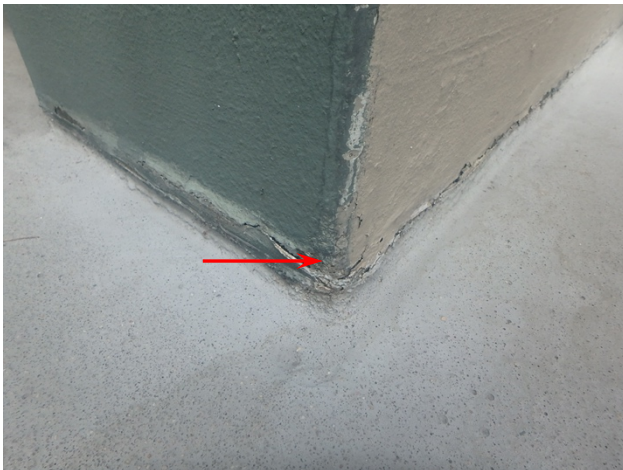
Typical sealant failure at the base of the wall.

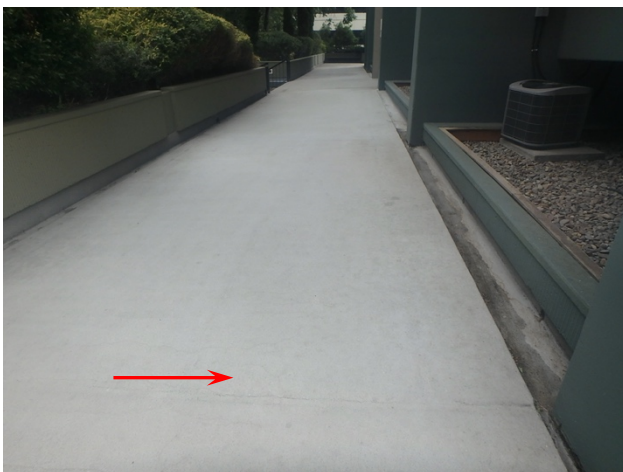
Expansion joints in the plaza deck are systemically failing causing leaks below.

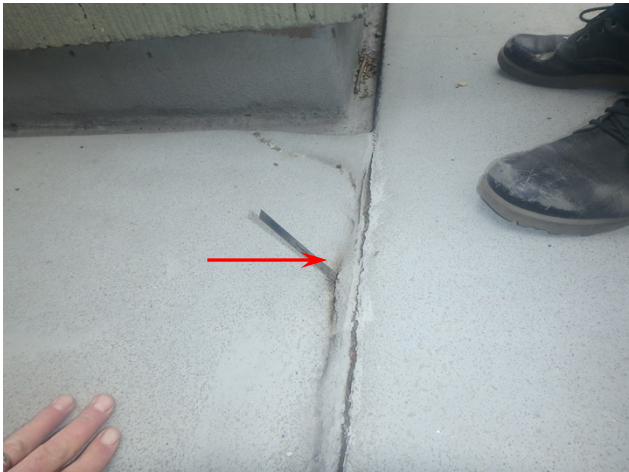
Explanatory Notes:
Close-up of a failed joint.

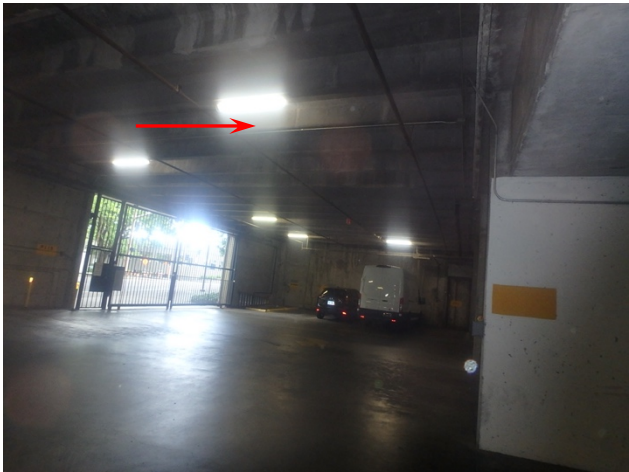
Explanatory Notes:
Leaks in the parking garage are widespread.

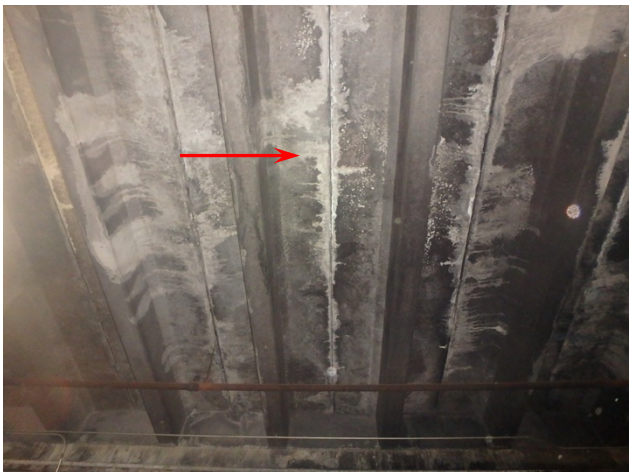
Explanatory Notes:
Leaks align with the precast concrete panel joints.

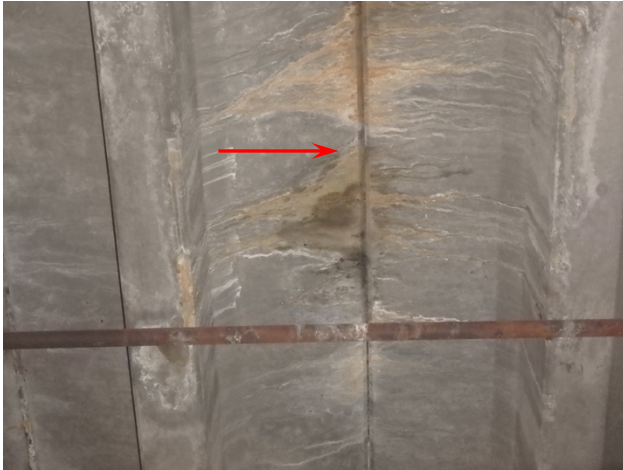
Additional example of leaks at the joints.

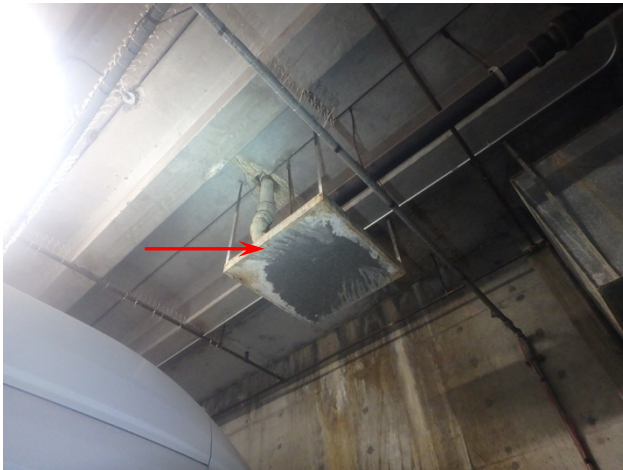
Various gutters and catches have been used to mitigate water dripping on vehicles.

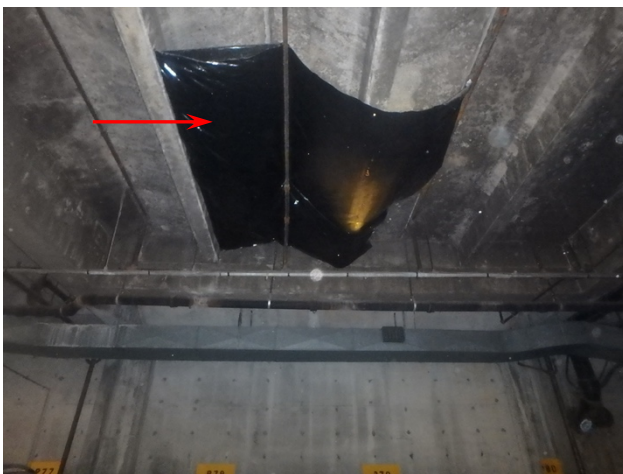
Most gutters are metal with a few being plastic.

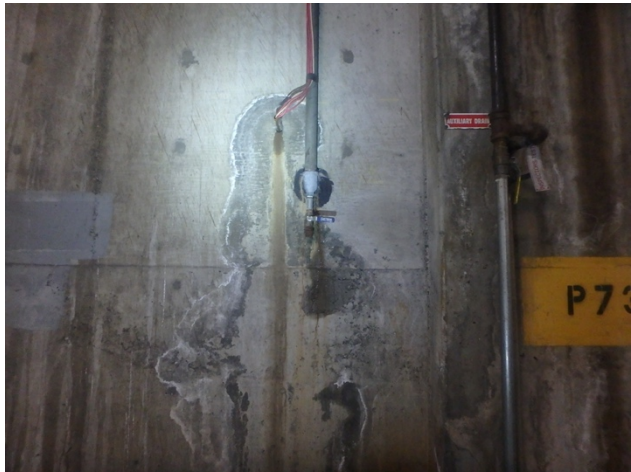
Leaks and damaged concrete were observed at several locations in the parking garage areas.

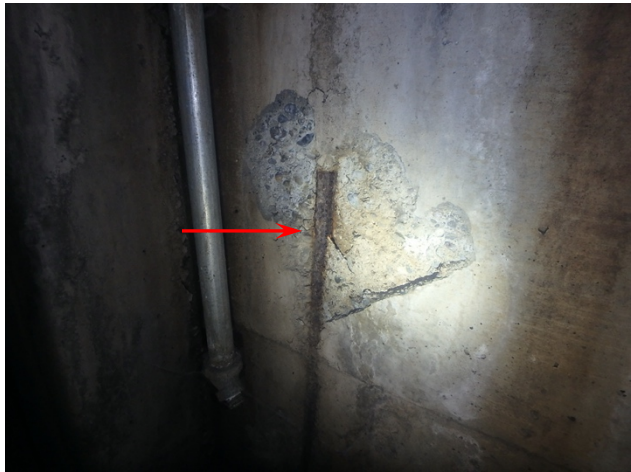
Moisture exposed rebar can cause rust jacking and spalling of the concrete.

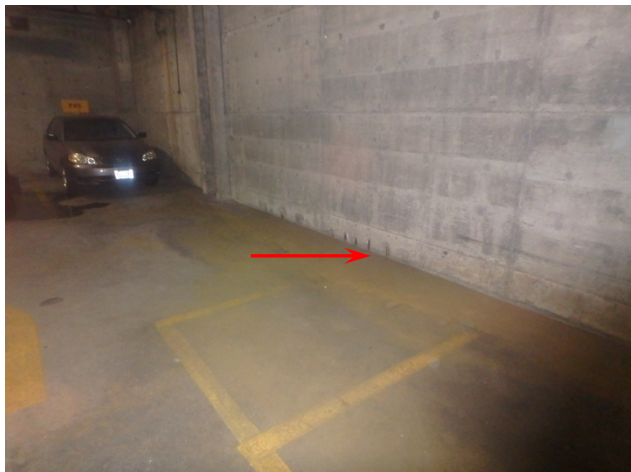
Additional area of spalled concrete where the flushing of the fire suppression system floods the floor.

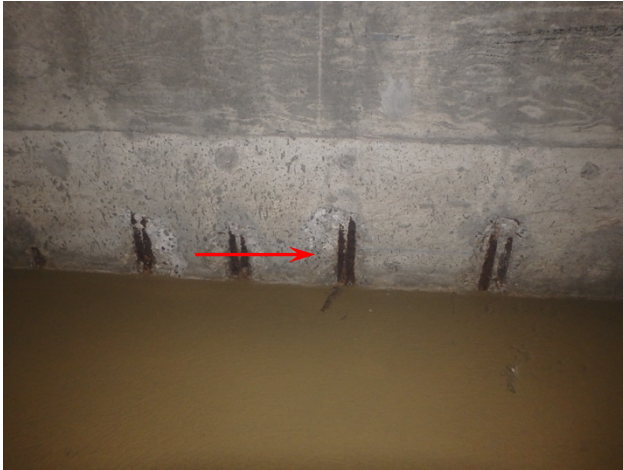
Continued corrosion can compromise the steel components over time.

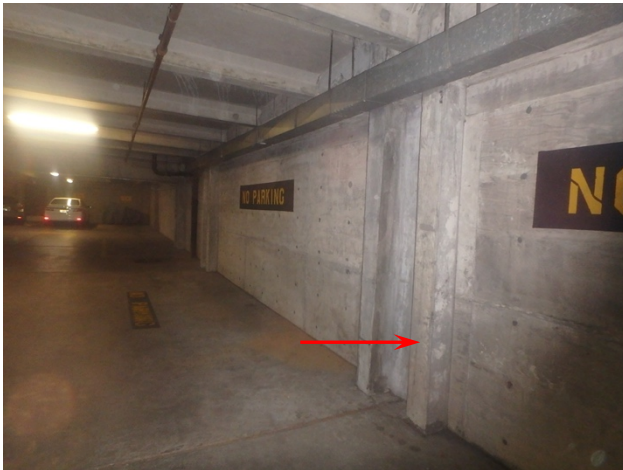
Cracks were observed in a concrete column at level 3 along the west elevation.

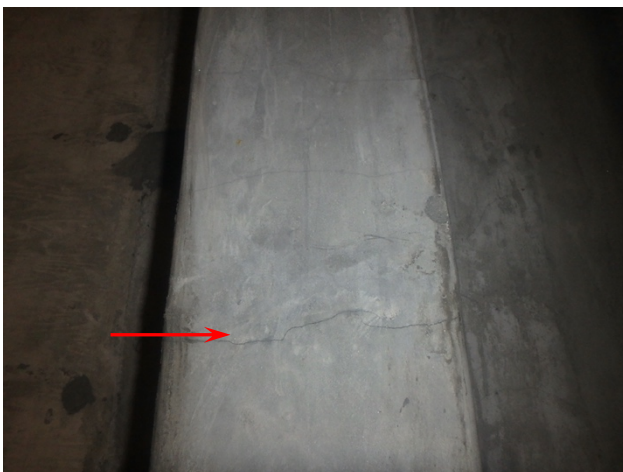
The column has been patched and the cracks have telegraphed through. If the cracks continue or worsen further analysis should be performed.

zinc rich primer coating to any visible rebar prior to repairs. The column at the west elevation of PG-3 should be monitored and reviewed by a licensed structural engineer if the condition worsens. The backflow for the fire suppression system should be serviced and the leak corrected.

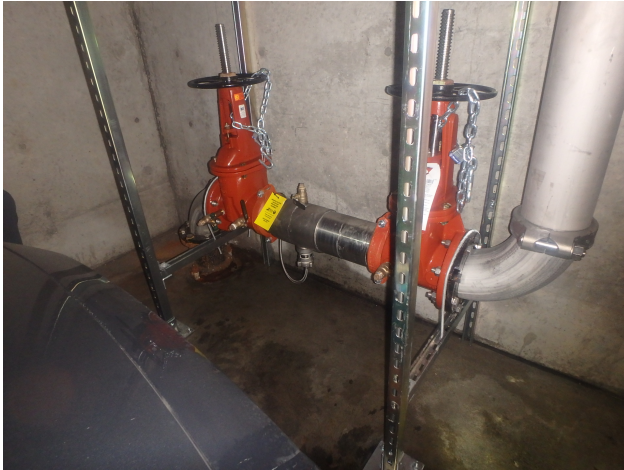
The backflow for the fire suppression system is leaking at PG-03 and causing pooling water on the garage floor that could pose a slip and fall hazard.

The backflow valves for the fire suppression system is leaking and flooding the lower parking level.

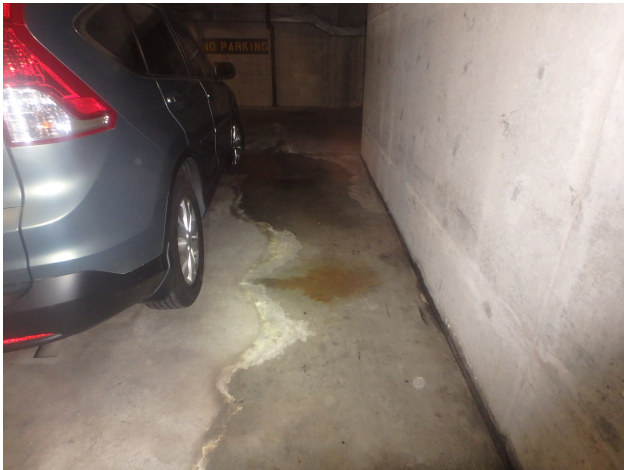
Water on the concrete poses a potential slip and fall hazard.

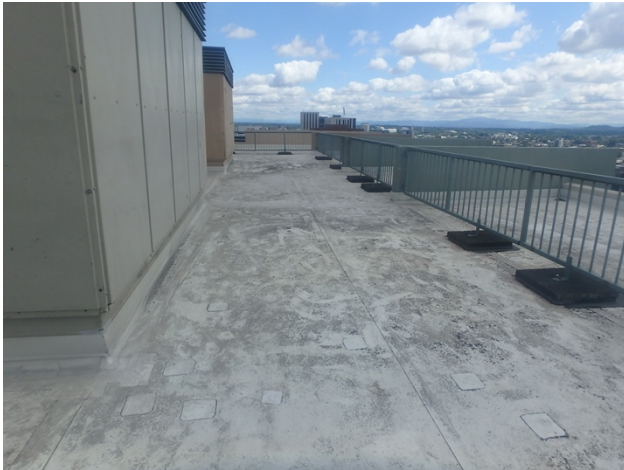
The TPO roof is in fair condition but has numerous patches.

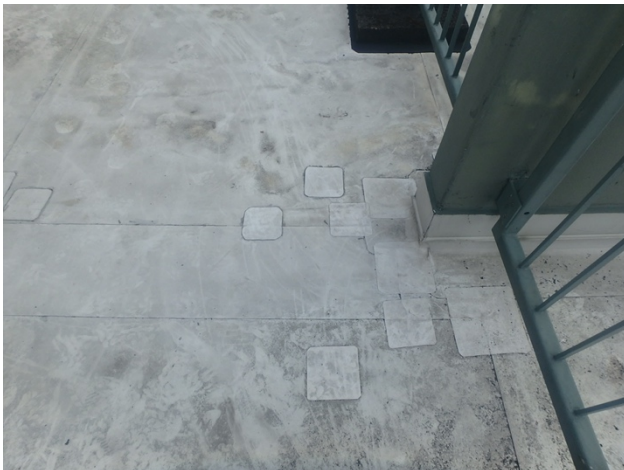
At some point patching will no longer be feasible and the roof should be replaced.

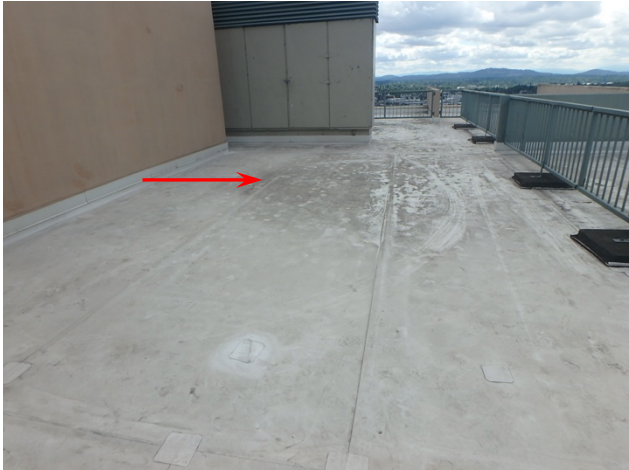
Signs of ponding are present surrounding the mechanical tower as the roof has poor slope and limited drainage.

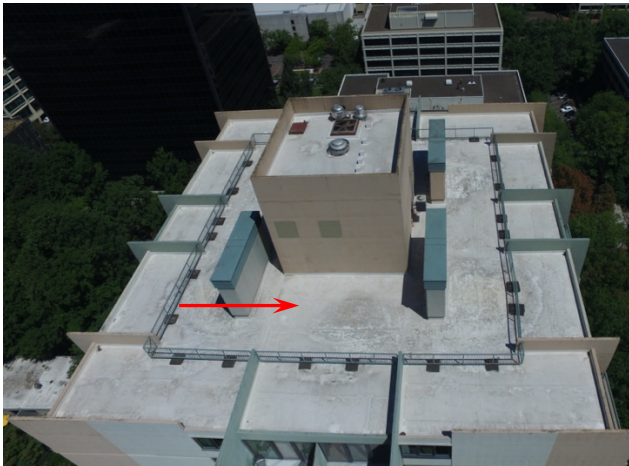
Signs of ponding are present surrounding the mechanical tower as the roof has poor slope and limited drainage.

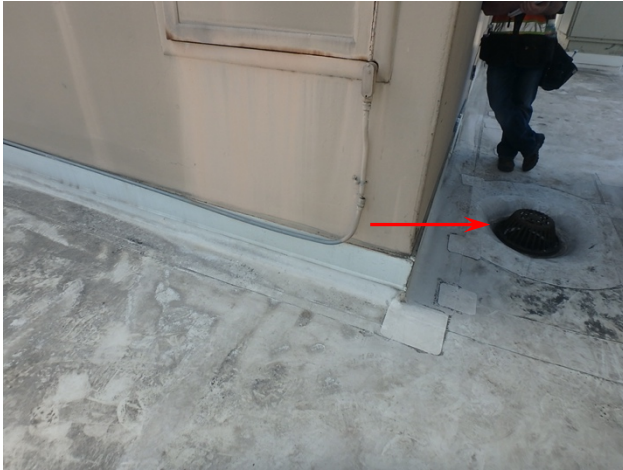
Single drains are located on the roof without an overflow drain and can flood the roof if clogged.
